ArubaOS 6.3.0.2

Release Notes

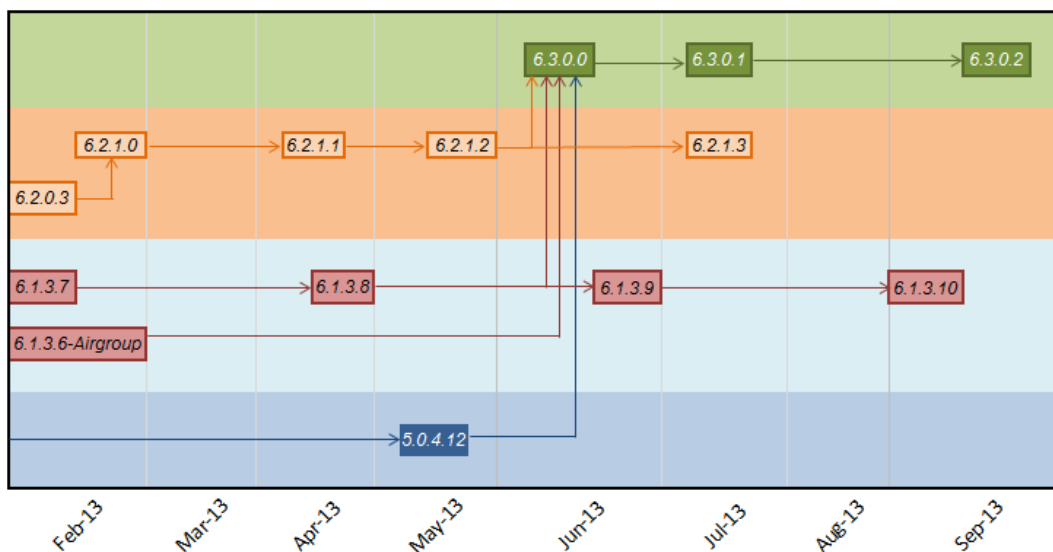
Figure 1 *ArubaOS Releases and Code Stream Integration*

The following illustration shows the patch and maintenance releases that are included in their entirety in ArubaOS 6.3.0.2:

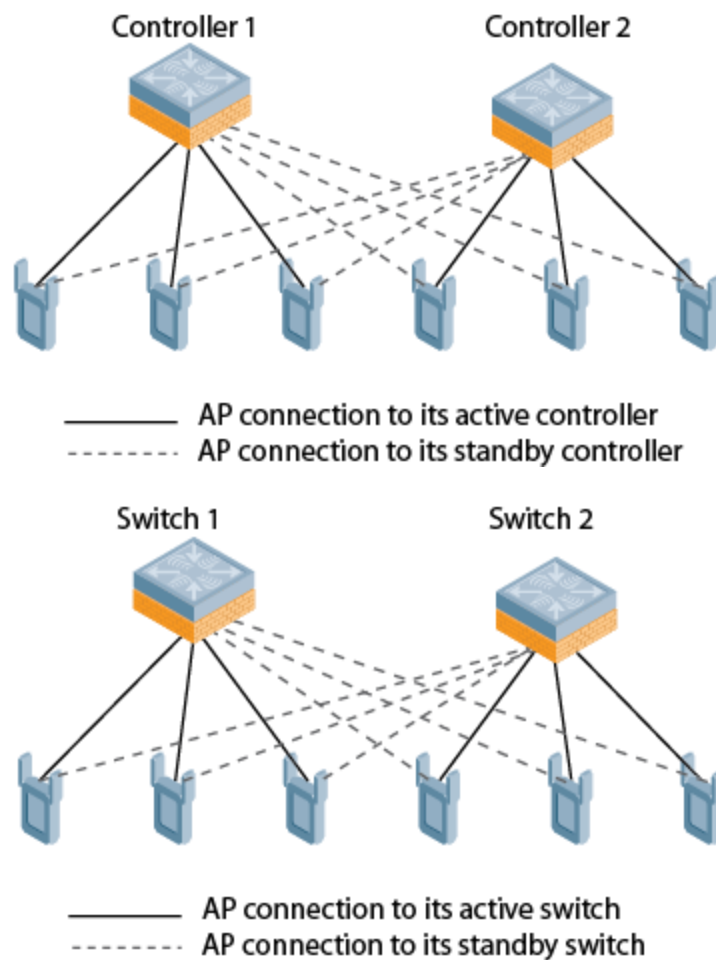
Figure 2 Active-Active HA Deployment

In this model, two controllers are deployed in dual mode. Controller one acts as standby for the APs served by controller two, and vice-versa. Each controller in this deployment model supports approximately 50% of its total AP capacity, so if one controller fails, all the APs served by that controller would fail over to the other controller, thereby providing high availability redundancy to all APs in the cluster.

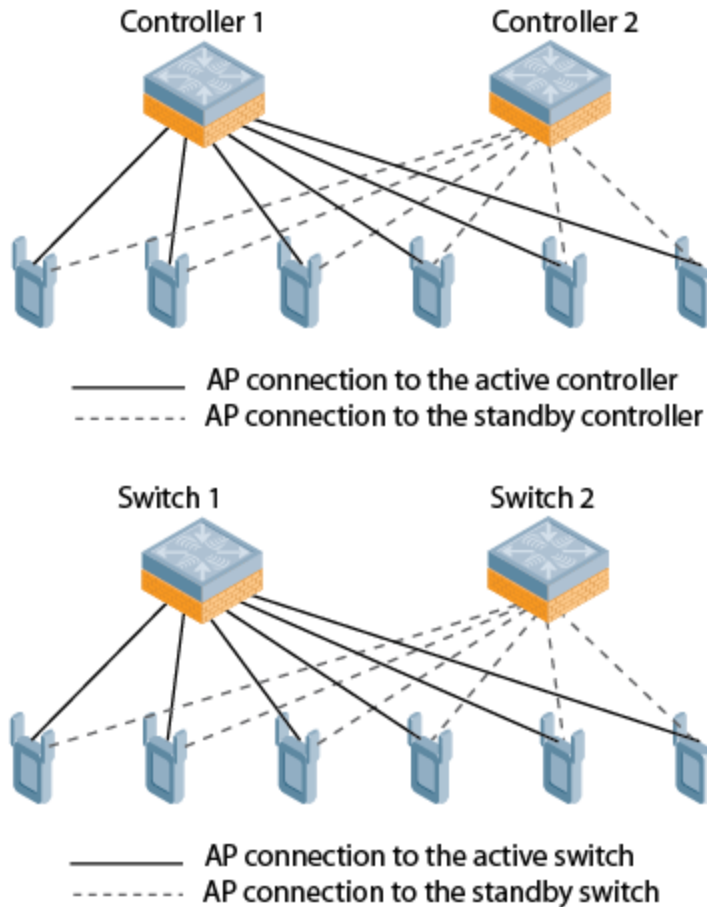
Figure 3 1:1 Active/Standby Deployment

In this model, the controller in active mode supports up to 100% of its rated capacity of APs, while the other controller in standby mode is idle. If the active controller fails, all APs served by the active controller would failover to the standby controller.

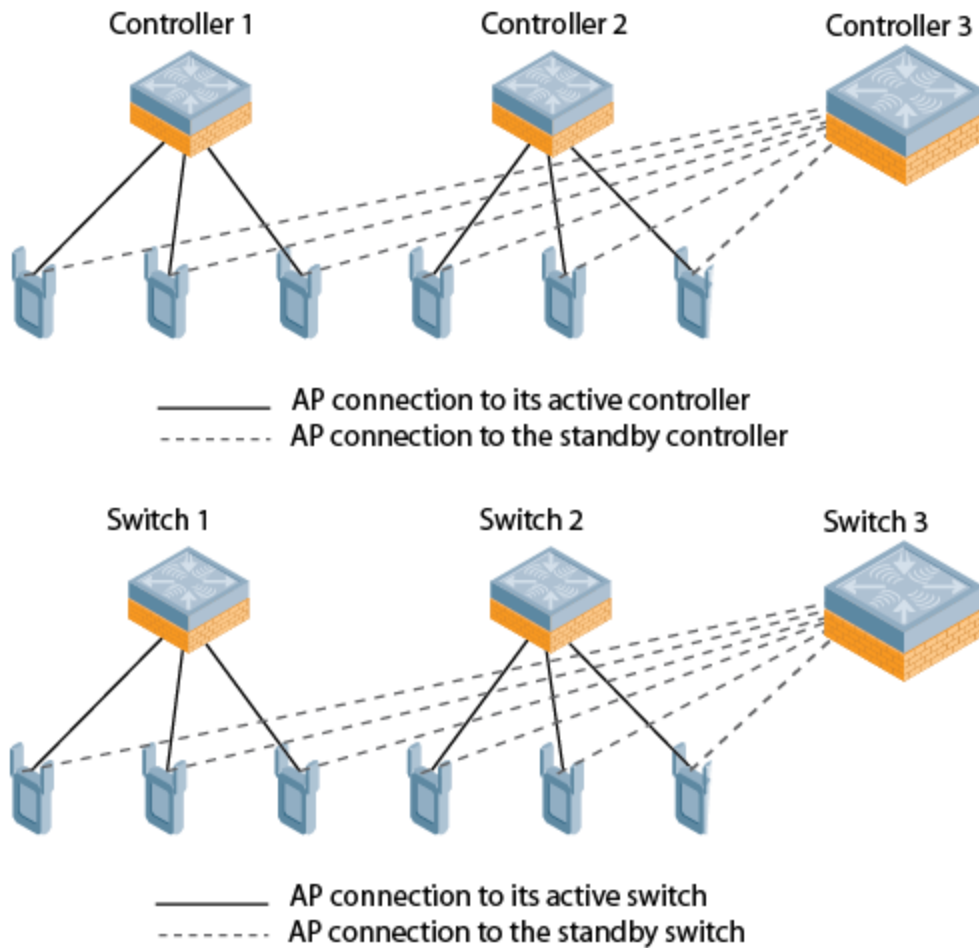
Figure 4 1:1 Active/Standby Deployment

In this model, each controller in active mode supports up to 100% of its rated capacity of APs, while one other controller is idle in standby mode. If an active controller fails, all APs served by the active controller would failover to the standby controller.

In the cluster shown in the example below, two active controllers use a single higher-capacity standby controller.
