# ArubaOS 6.4.2.0

Release Notes

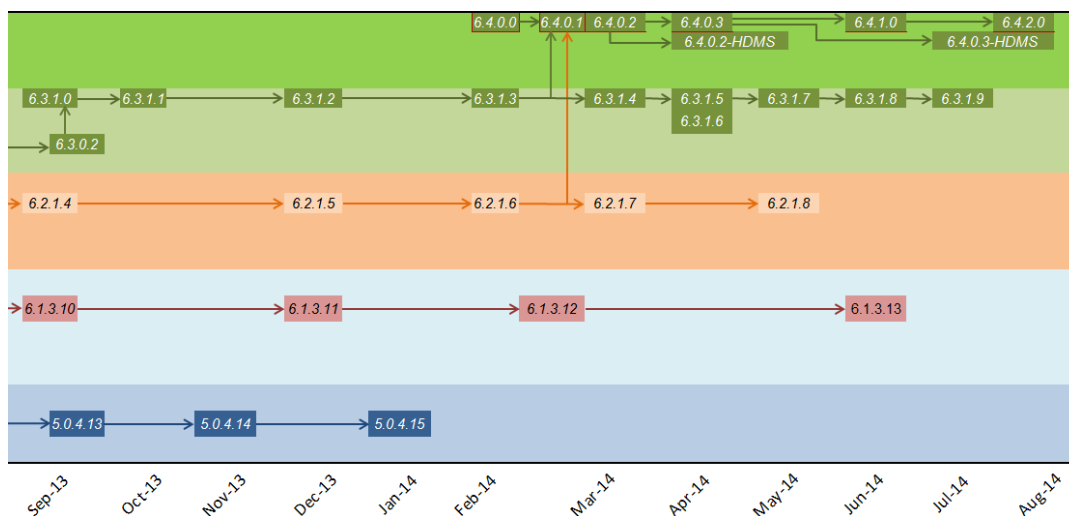
**Figure 1** ArubaOS Releases and Code Stream Integration

The following illustration shows the patch and maintenance releases that are included in their entirety in ArubaOS 6.4.2.0:
