ArubaOS 6.4.1.0

Release Notes

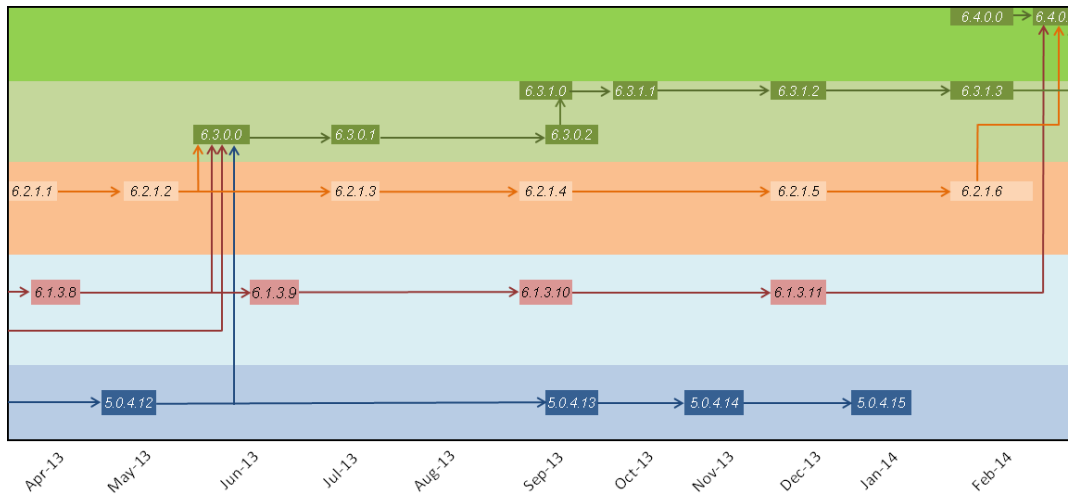
Figure 1 ArubaOS Releases and Code Stream Integration

The following illustration shows the patch and maintenance releases that are included in their entirety in ArubaOS 6.4.0.1:
