ArubaOS 6.3.0.1

Release Notes

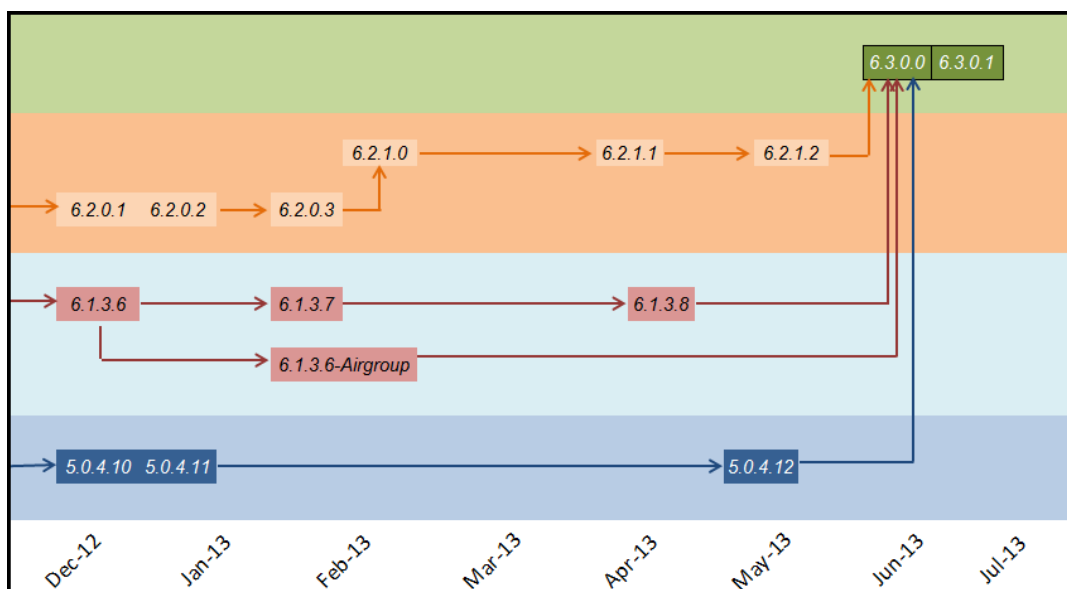
Figure 1 *ArubaOS Releases and Code Stream Integration*

The following illustration shows the patch and maintenance releases that are included in their entirety in ArubaOS 6.3.0.1:

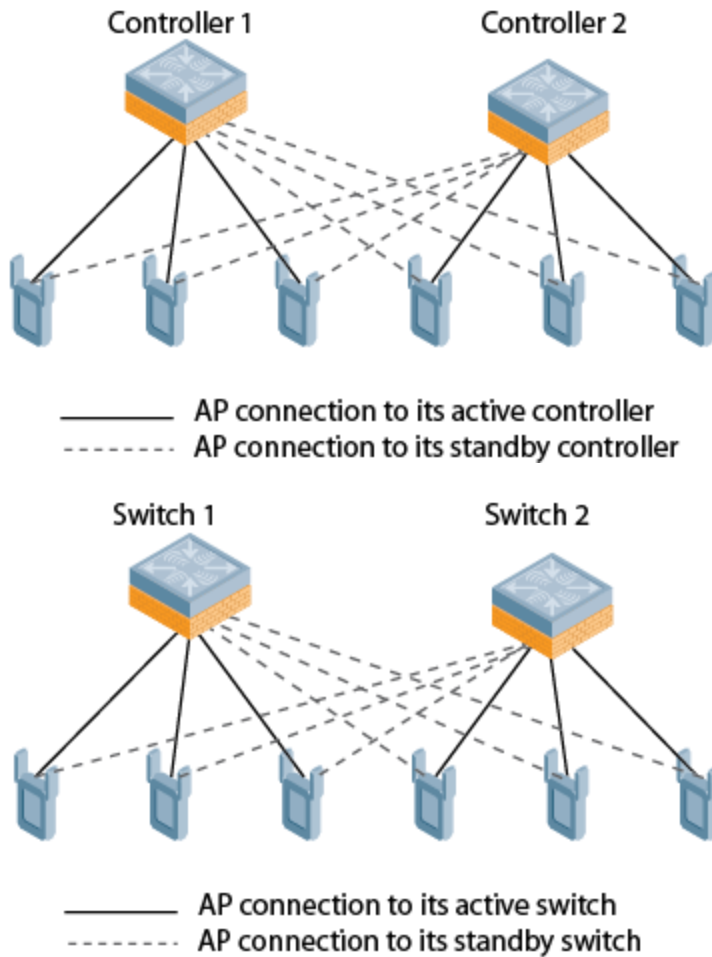
Figure 2 Active-Active HA Deployment

In this model, two controllers are deployed in dual mode. Controller one acts as standby for the APs served by controller two, and vice-versa. Each controller in this deployment model supports approximately 50% of its total AP capacity, so if one controller fails, all the APs served by that controller would fail over to the other controller, thereby providing high availability redundancy to all APs in the cluster.

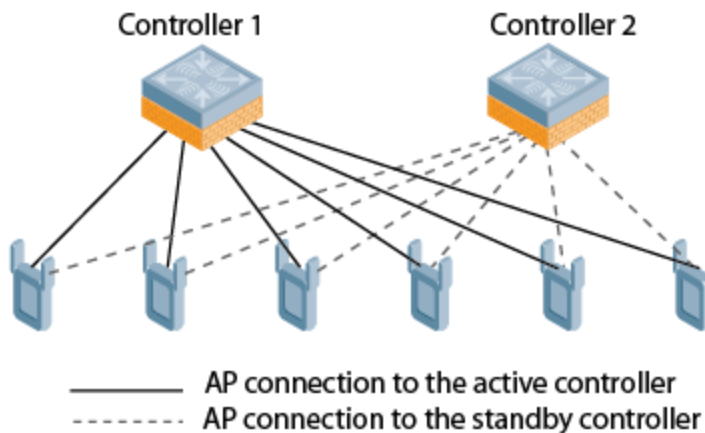
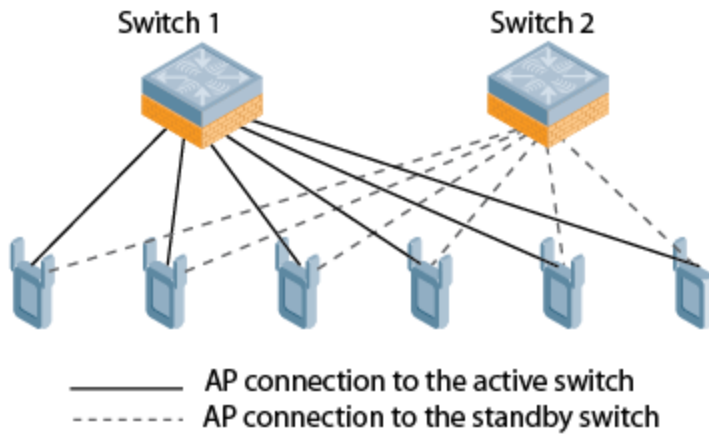
Figure 3 1:1 Active/Standby Deployment

In this model, the controller in active mode supports up to 100% of its rated capacity of APs, while the other controller in standby mode is idle. If the active controller fails, all APs served by the active controller would failover to the standby controller.

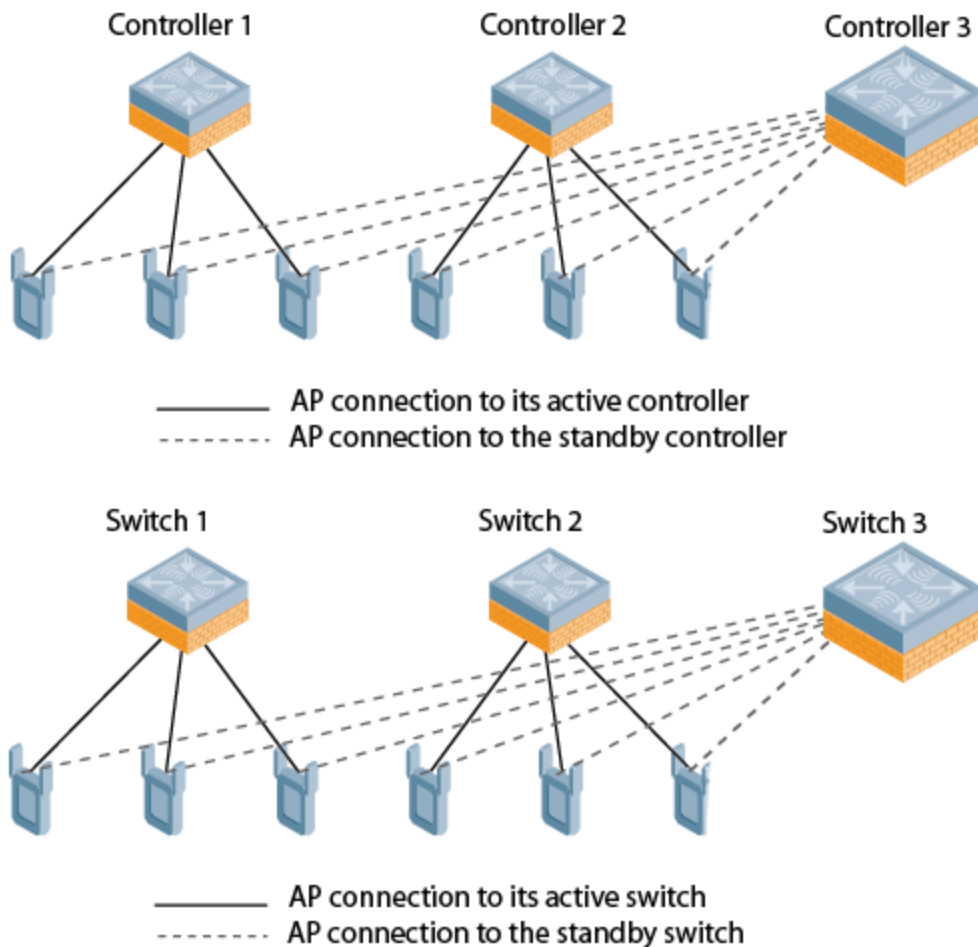
Figure 4 1:1 Active/Standby Deployment

In this model, each controller in active mode supports up to 100% of its rated capacity of APs, while one other controller is idle in standby mode. If an active controller fails, all APs served by the active controller would failover to the standby controller.

In the cluster shown in the example below, two active controllers use a single higher-capacity standby controller.
